Manhole Inspection Summary

Manhole # S31KK1006MH

Inspection ☐ Is Incomplete Rating: **4) Poor**

Location Address: **101 OVERHILL RD**

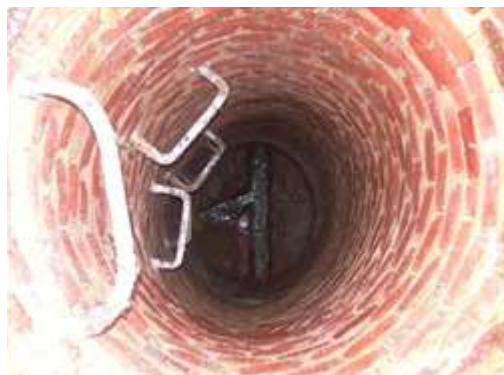
Top View

Adjustment and Barrel infiltration. Bench debris.

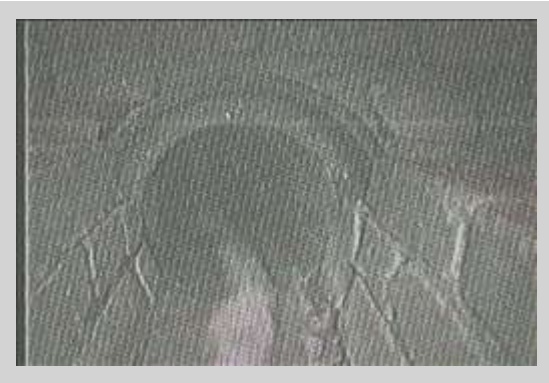
8 in. Circular Gravity Sewer Pipe Out @ 12 O'Clock

Channel deterioration.

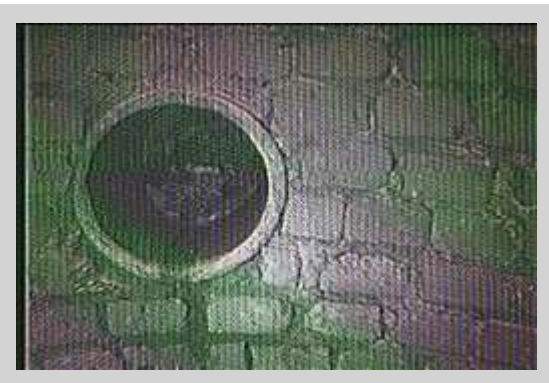
8 in. Circular Gravity Sewer Pipe In @ 6 O'Clock

Infiltration: **None** Pipe Seal Cond: **Broken**

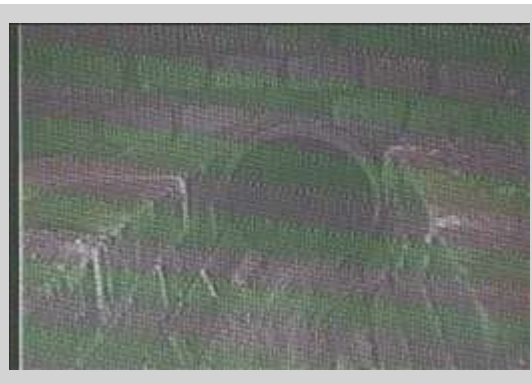
Drop In @ 6 O'Clock

Barrel deterioration and infiltration. Channel deterioration.

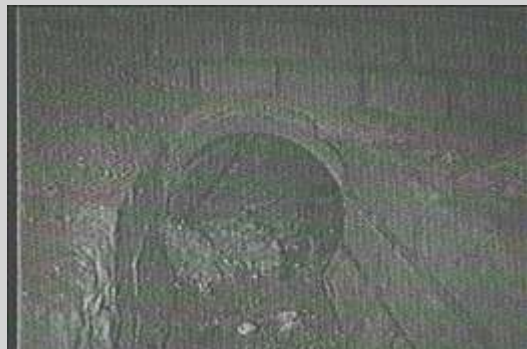
Pipe In @ 8 O'Clock

Deposits: ☐ None ☒ **Mud** ☐ Sludge ☒ **Debris** ☐ Grease

Silt Depth: **3** (in.) Deposits Extent: **Medium**

Infiltration: **Evidence** Pipe Seal Cond: **Cracked**

Connects To: **Stub connection / abandoned**
